Additional Product Installation Support

For Product: Mustang Instrument Cluster Modules p/n: 2024-7xx

Last Update: November 16, 2005

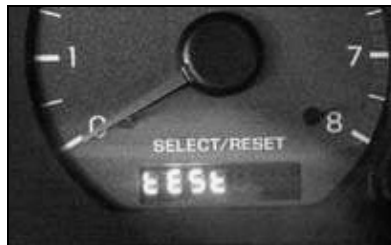
Figure 1.

- A. Put key in the ignition, but do not turn it. Push and hold trip/reset button. Continue holding button down.
- B. Turn the key to the on position while holding button. Continue holding button until "test" appears on digital odometer/trip readout (see Figure 1).
- C. The pointers will all sweep to their extreme points and sweep back to their starting positions. The digital readout will say "GAGE".
